Exploring The Behaviour of Dapped Wet Wall-To-Wall Connections Under Uniformly Distributed Load

ABSTRACT

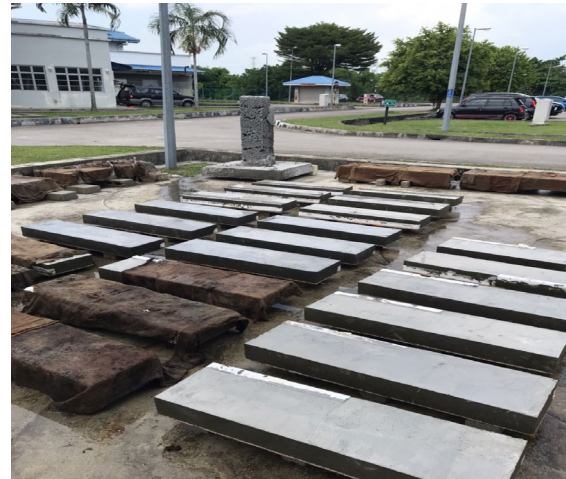
FIGURE 3. Curing of the wall panels

A total of 12 formworks measuring 1000 mm high x 300 mm wide x 100 mm thick were made to prepare the wall panels. The formworks were used to pour the wall panels, with the proposed connection shape and dimension formed using the Styrofoam method at one end of the form. The fresh mortar was mixed in a concrete mixer, poured into the prepared formwork in three layers and compacted with a vibrator to ensure that the entire mixture was evenly distributed in the formwork and well compacted to avoid subsequent honeycombing. All the poured test specimens were cured in a laboratory, with moistened bags placed on the specimens.

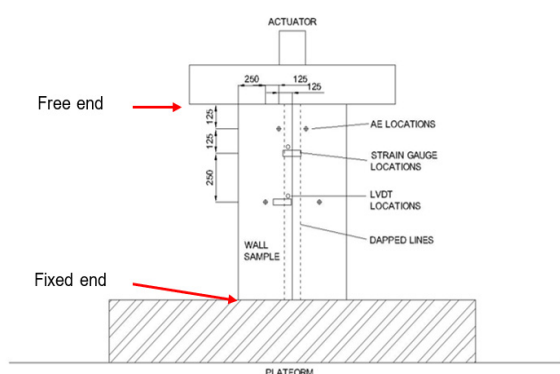
FIGURE 4. Schematic diagram of the wall-to-wall connection setup with other instruments (units in mm)

Figure 4 shows the schematic diagram of the test setup of the wall-to-wall connections and illustrates the arrangements made for other measurements, such as linear vertical displacement transducers (LVDTs), strain gauges and AE sensors. The LVDTs were used to measure deflection at selected locations and strategically positioned on the wall panel surfaces, 240 mm (designated as D1) and 490 mm (designated as D2) from the top of each specimen, respectively, as shown in Figure 5. This was to record the horizontal displacement when uniformly distributed load was applied to the top surface. The strain gauges were located at 250 mm (fourth quarter of the wall height) and 500 mm (half the wall height). They were designated as SG1 and SG2, as shown in Figure 5. SG1 was placed at 250 mm to record the strain at the connection interface and SG2 was placed at 500 mm to record the strain in the dapped area. Four AE sensors were fixed at selected locations and designated as CH1, CH2, CH3 and CH4, as shown in Figure 5. Each specimen was held in a fixed position on the test platform and uniformly distributed load was applied on top of the wall-to-wall connection. The wall-to-wall connections were statically loaded to failure at a constant load rate of 0.1 mm/min. The crack pattern

Four VS75-V sensors were placed on one side of each specimen (see Figure 4). The coordinates of the sensors are shown in Table 2, with the x and y positions indicated, while the x and y positions can be seen in Figure 5. Both CH1 and CH2 were used to detect crack initiation and propagation at each connection. Sensors CH3 and CH4 were used to detect cracking in the dapped section of the wall panels.

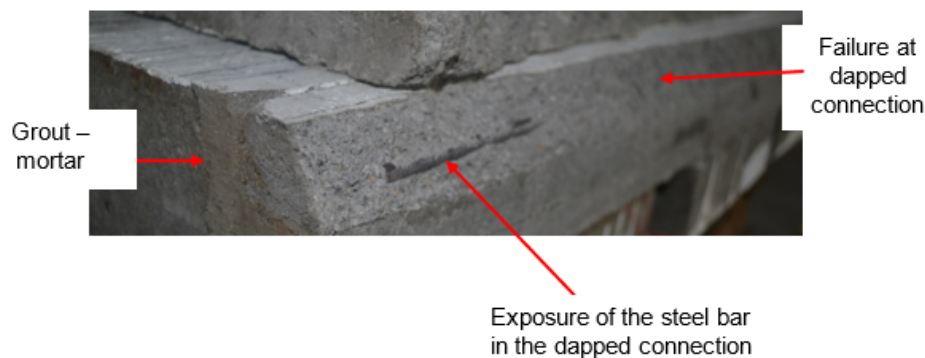
FIGURE 12. Failure of the wall connection at the joint interface of grout mortar and the dapped end for wall-to-wall connection Type 2

Figures 11 and 12 show the failures that occurred at the joints between two panels for Type 1 and Type 2. For Type 1, most failures for this type of wall-to-wall connection occurred at the dapped, not at the concrete interface or concrete grout. A similar failure pattern can be seen in Figure 12 for Type 2, the lightly vertical reinforced dapped wet. This indicated that the concrete grout was a good adhesive for the connection between two wall panels, as most of the failures with this connection occurred at the dapped.

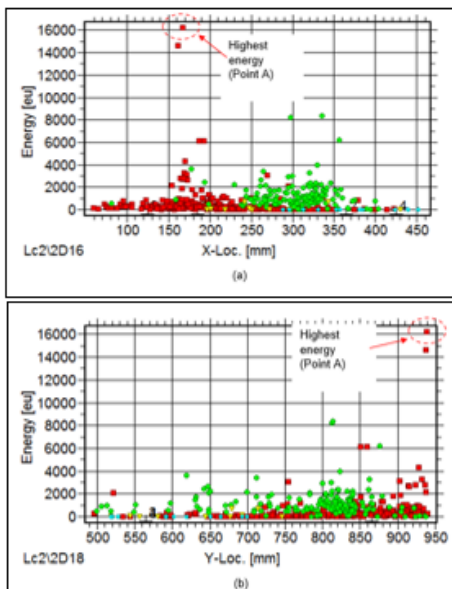
FIGURE 17. AE energy with respect to (a) X-location and (b) Y-location for Type 1

Figure 17(a) and 17(b) shows the crack formation that originated from the dapped section of the connection on the top of the specimen T1S3. The observed crack lines shown in Figure 14 (red line) matched the AE hits detected by CH2 (green). The highest AE energy for Type 1 (16100 eu) was found at 165 mm from the origin. Other high-intensity AE energy was detected by CH1 (red), with visual observation unable to identify the cracks on the specimen surface, proving that cracks or microcracks were formed in the specimen matrix (Md Nor, 2018). CH3 (yellow) and CH4 (blue) each registered a less intense number of acoustic emission hits than either CH1 or CH2.
