## Structural Rehabilitation of API Steel Pipes Using GFRP Under Dynamic Condition

### ABSTRACT

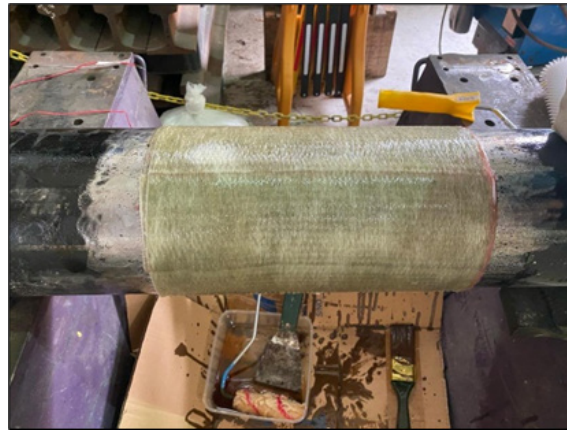
FIGURE 3. Application of composite wrap.

Following corrosion induction, selected pipes underwent rehabilitation using GFRP patches. Surface preparation involved abrasive blasting to remove rust and create a profile conducive to adhesion. An epoxy putty was used to fill the corrosion void and allowed to cure for 24 hours at room temperature before applying the composite wrap. Subsequently, an epoxy primer was applied, followed by the placement of GFRP sheets cut to predetermined sizes. The patches were applied using a wet layup method, ensuring thorough impregnation of the fibres with the epoxy resin. The curing process was conducted at ambient

temperature for five days. The wrapping process is illustrated in FIGURE 3. The selection of the type and number of GFRP layers was guided by the dual objectives of restoring the corroded portion of the pipe and enhancing its overall structural integrity beyond the original strength. Specifically, three layers of GFRP were applied to ensure sufficient strength and durability. Furthermore, this approach has been suggested by Lim et al. (2019) & Muda et al. (2022). This approach not only addresses the immediate need to repair the corroded sections but also provides additional reinforcement, potentially increasing the load-bearing capacity and bending stiffness of the pipe, thus extending its service life.

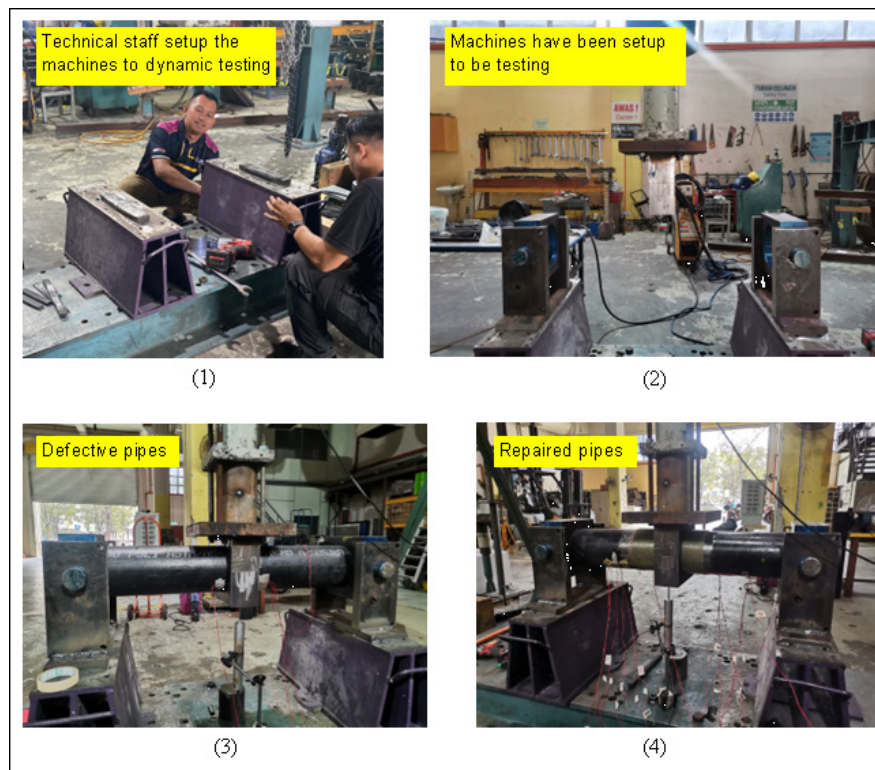
FIGURE 4. Dynamic test specimens.

Cyclic loading testing focused on applying cyclic loads to both unrepaired and repaired pipes. A servo-hydraulic testing machine was used to apply a sinusoidal load with an amplitude correlating to 50% of the pipe's predicted yield strength at a frequency of 0.5Hz. Testing was executed starting from 1mm, 2mm, and 3mm increments until failure for unrepaired pipes, and 1mm, 3mm, and 3mm increments until failure for repaired pipes. Each

amplitude increment was tested for two cycles to ensure repeatability and reliability of the results. This regimen mimics the fluctuating stress conditions encountered in service. Linear Variable Differential Transformers (LVDT) were strategically placed to capture deformation behaviour and stress concentration points, facilitating a comprehensive analysis of the pipes' dynamic response. The testing setup is shown in Figure 4 shows the process before the execution of dynamic test.

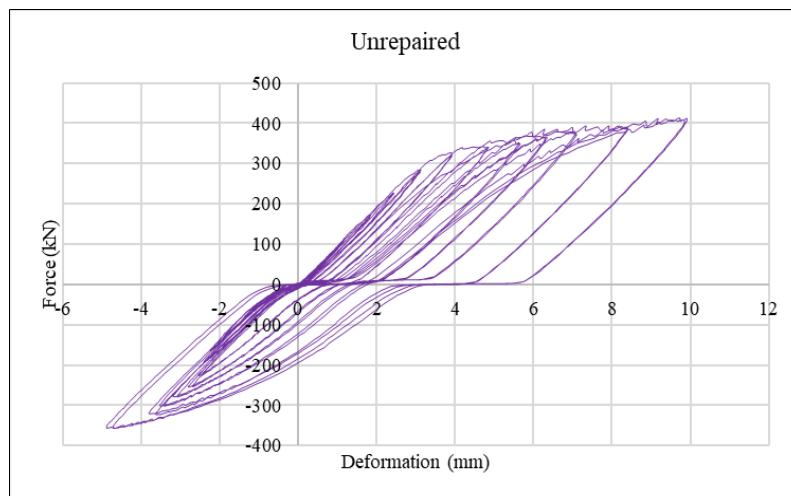
FIGURE 5. Force vs displacement curve – unrepaired

Referencing in Table 2 the cyclic loading tests on the unrepaired API 5L X42 pipes reveal a progressive increase in both the maximum force applied and the corresponding deformation as the stroke length increases. At an initial stroke of 1mm, the maximum force applied is 67.84 kN with a deformation of 0.8 mm.

This force escalates to 404.8 kN at a 12mm stroke, with a corresponding deformation of 9.01 mm. The data indicates that the unrepaired pipes exhibit significant deformation under increasing load, suggesting a reduced structural

integrity and an increased likelihood of failure under dynamic loading conditions. The force vs. displacement curve in Figure 5 clearly illustrates this trend, showing a near-linear relationship initially, followed by a plateau as the material approaches its yield strength.

The force vs. displacement curves for both unrepaired and repaired pipes provide visual confirmation of these findings. The unrepaired pipes' curve shows a steep initial slope followed by a plateau, indicating a rapid approach to the material's yield strength and subsequent risk of failure. On the other hand, the repaired pipes' curve demonstrates a more gradual slope and a higher peak force, signifying enhanced load distribution and increased resistance to deformation. The comparative analysis of relative errors further reinforces the benefits of GFRP rehabilitation. The significant reduction in relative error for both force and deformation between the unrepaired and repaired conditions suggests that GFRP wrapping not only restores the pipes' original strength but also provides additional reinforcement, extending their service life and reliability under dynamic loads.

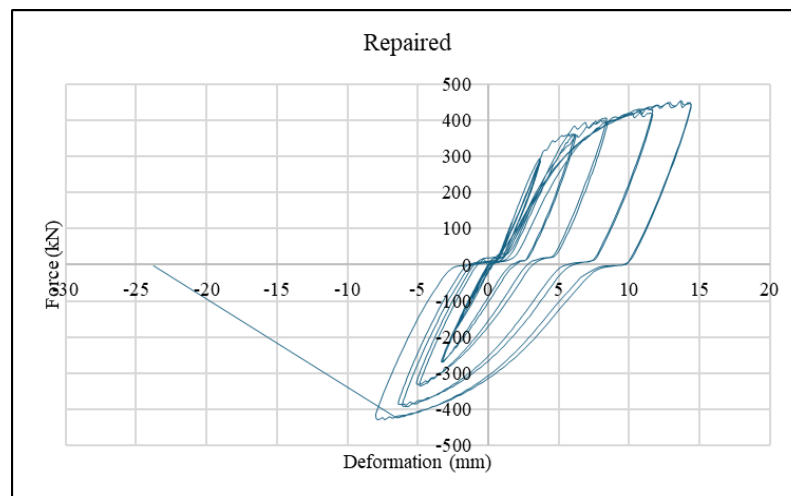
FIGURE 6. Force vs displacement curve – repaired

Conversely in Table 3, the GFRP-repaired pipes demonstrate improved mechanical performance under the same testing conditions. At a 1mm stroke, the maximum force applied is lower at 28.98 kN with deformation of 0.65 mm, reflecting the initial stiffness imparted by the GFRP wrapping. As the stroke increases to 18mm, the maximum force reaches 452.87 kN with a deformation of 14.41 mm. This significant increase in load-bearing capacity and corresponding deformation capacity underscores the effectiveness of GFRP in enhancing the structural integrity of the repaired pipes. The force vs. displacement curve in Figure 6 highlights the enhanced performance, showing a more gradual slope and a higher load-bearing threshold compared to the unrepaired pipes.
